Transition Plan for **ADA Compliance** of Public Facilities Located within the Right-of-Way

City of Irondale

August 16, 2016

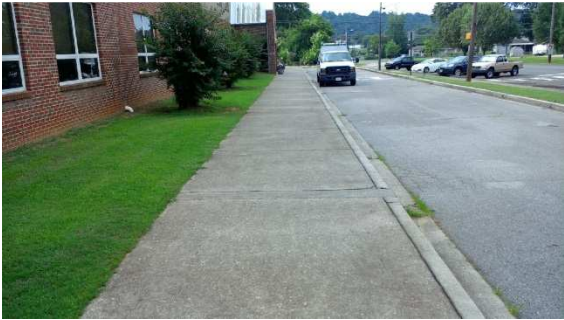
FIGURE 1: COMPLIANT SIDEWALK

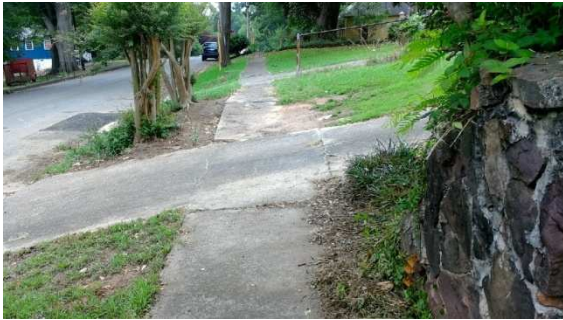
**FIGURE 2: NON-COMPLIANT SIDEWALK
 (DUE TO VERTICAL DISCONTINUITIES AND CROSS
 SLOPES EXCEEDING 2%, ESPECIALLY AT DRIVEWAY)**

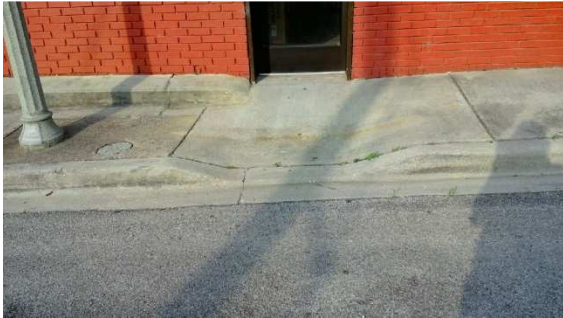
**FIGURE 4: NON-COMPLIANT CURB RAMP
 (DUE TO EXCESSIVE SLOPES, LACK OF DETECTABLE WARNING
 SURFACE, AND LACK OF TURNING AREA)**

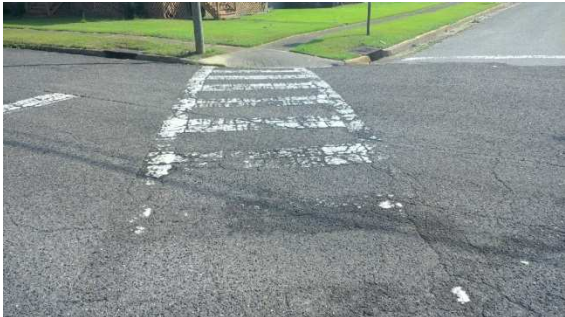
FIGURE 6: NON-COMPLIANT CROSS WALK
 (DUE TO EXCESSIVE CROSS SLOPES, NEEDS RE-STRIPING IN ORDER TO CONFORM TO CURRENT MUTCD STANDARDS)

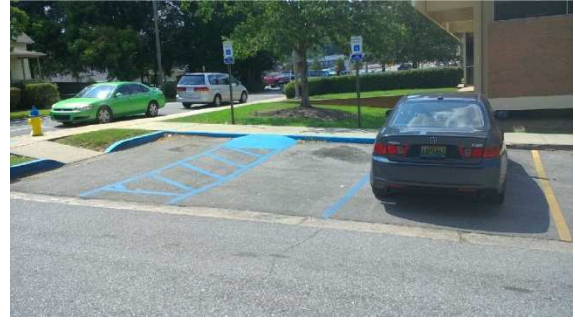
FIGURE 8: NON-COMPLIANT ON-STREET PARKING AREA
(DUE TO SLOPES IN EXCESS OF 2% AND LACK OF 8' ACCESS AISLE)

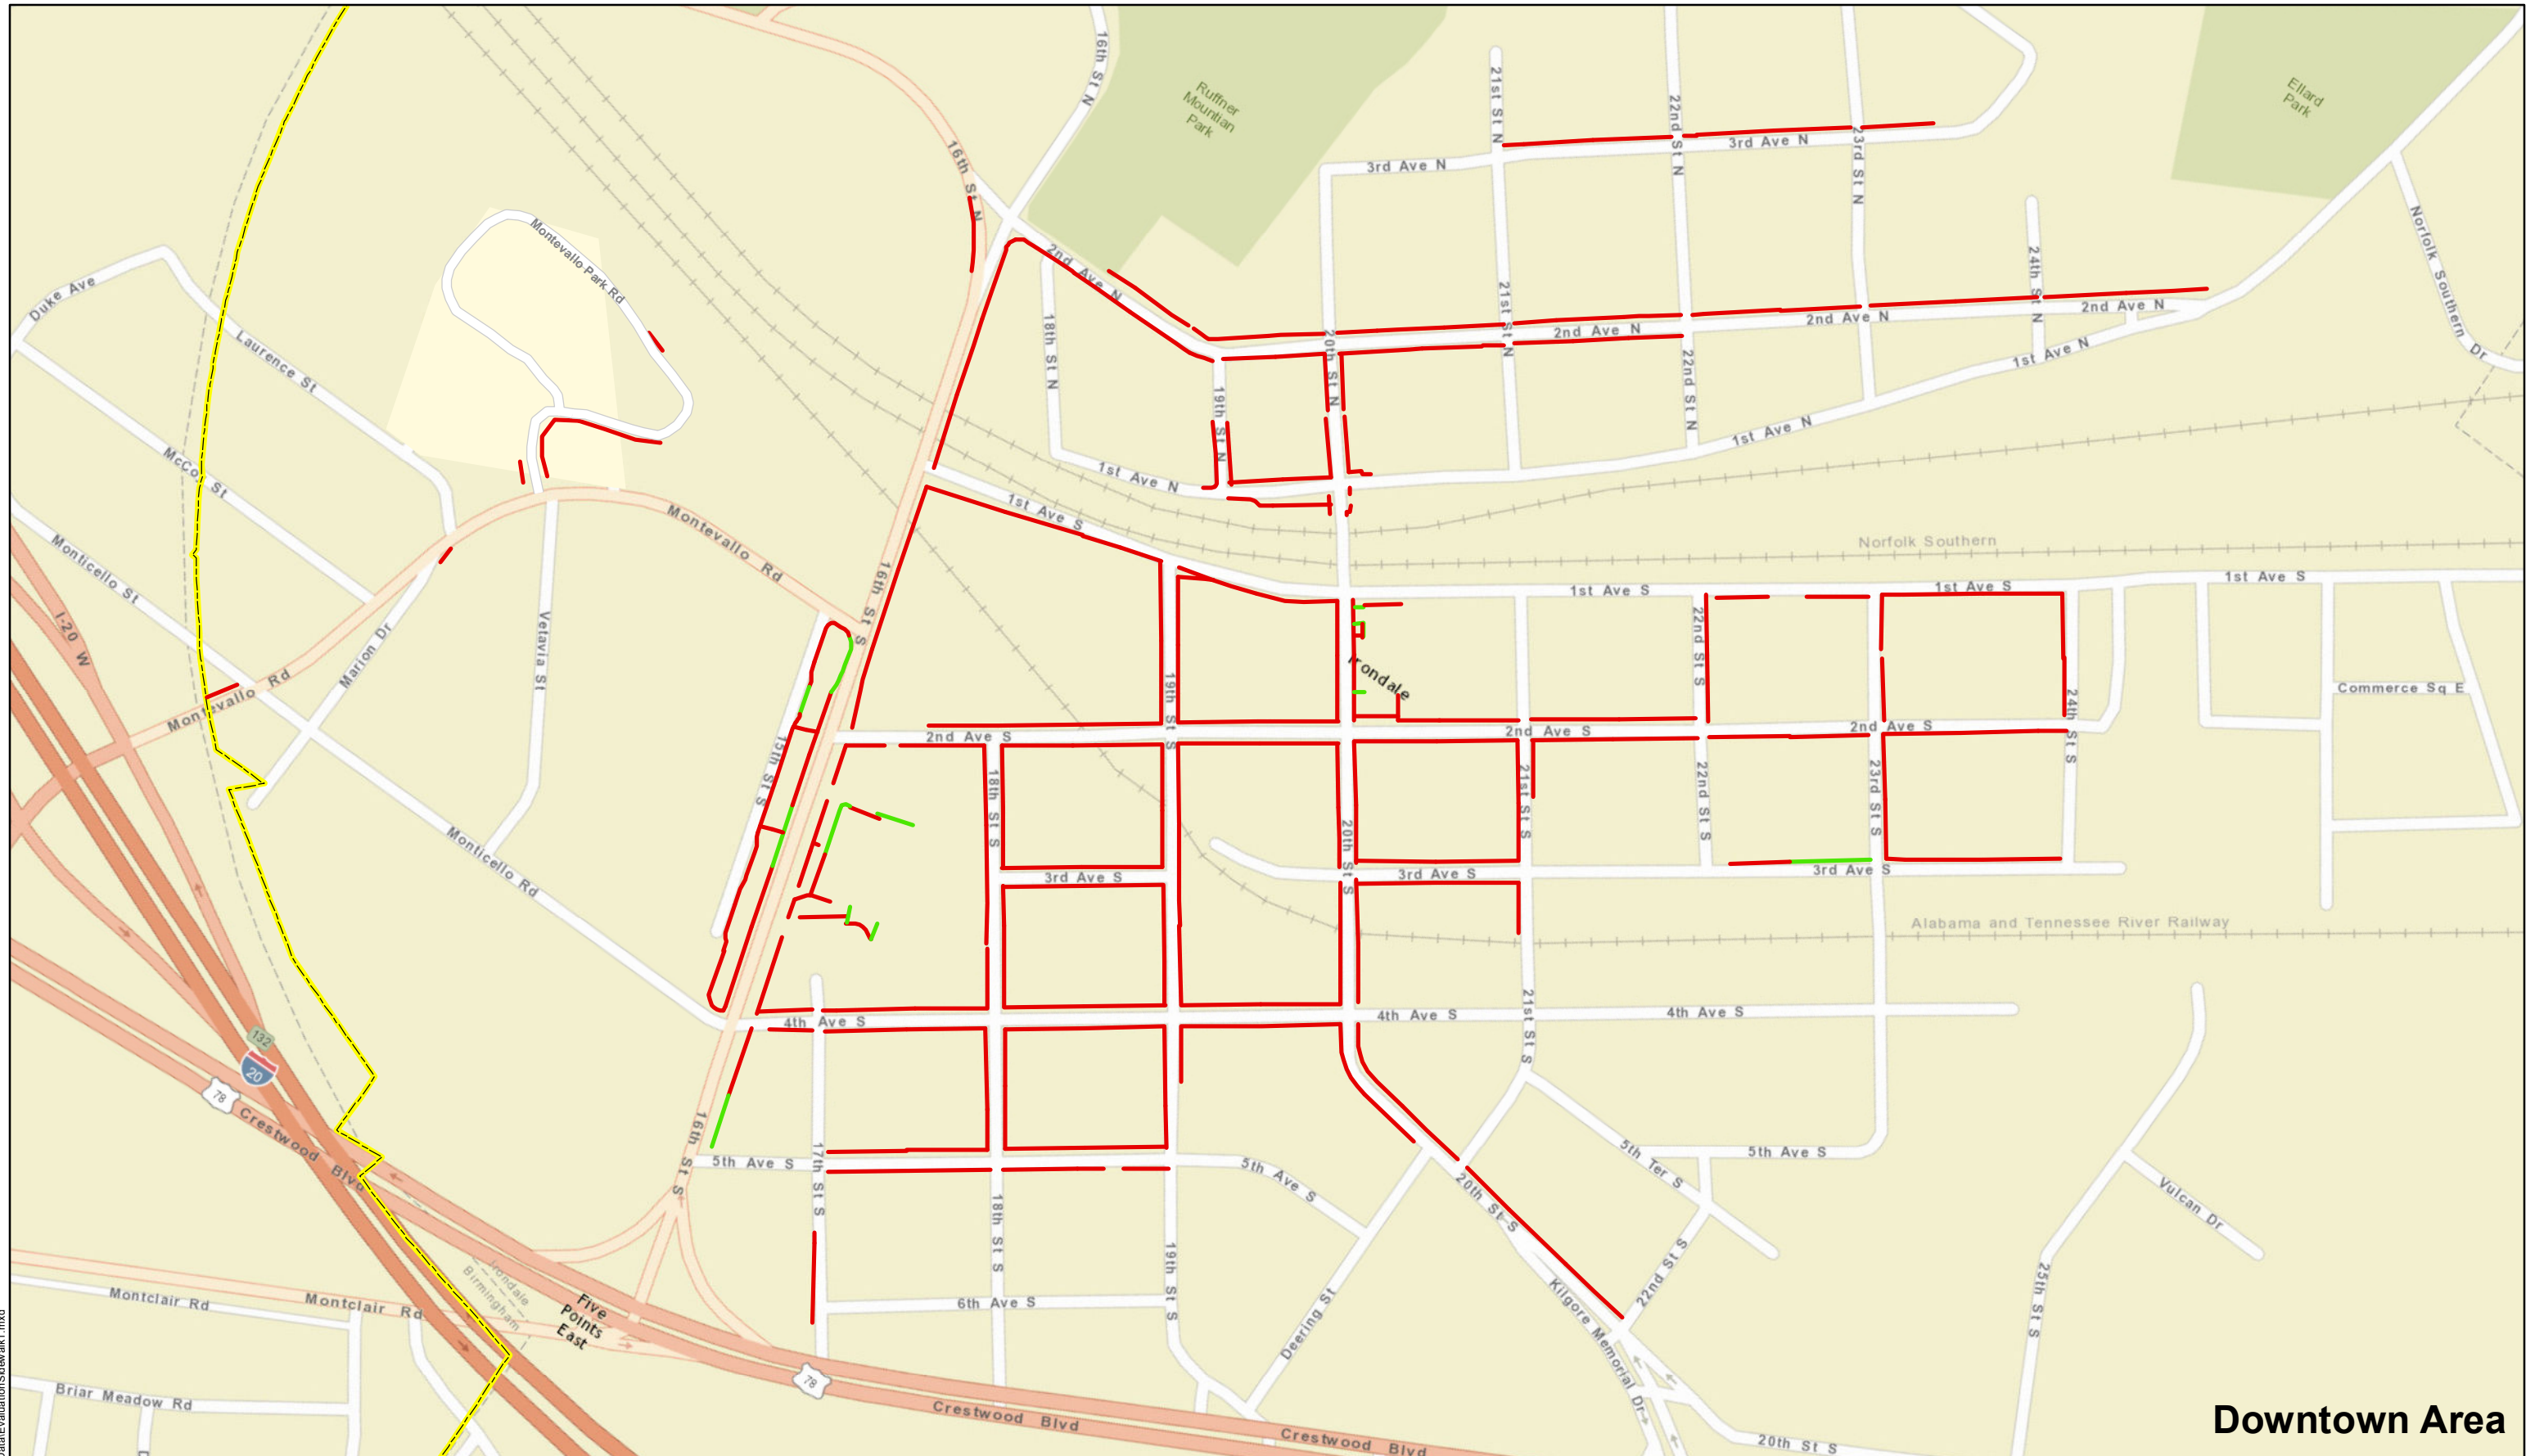
Sidewalks (1 of 2) - Appendix B.1

Reference Appendix B.1 of this report for a map of all sidewalks located within the City. Sidewalks shown in red on the map are non-compliant, while compliant sidewalk sections are shown in green. Examples of both compliant and non-compliant sidewalks within the City are shown in Figures 1 and 2.
